OFFICE OF THE MARION COUNTY SURVEYOR

SECTION RECORD CORNER

SECTION 21 TOWNSHIP 17 RANGE 2

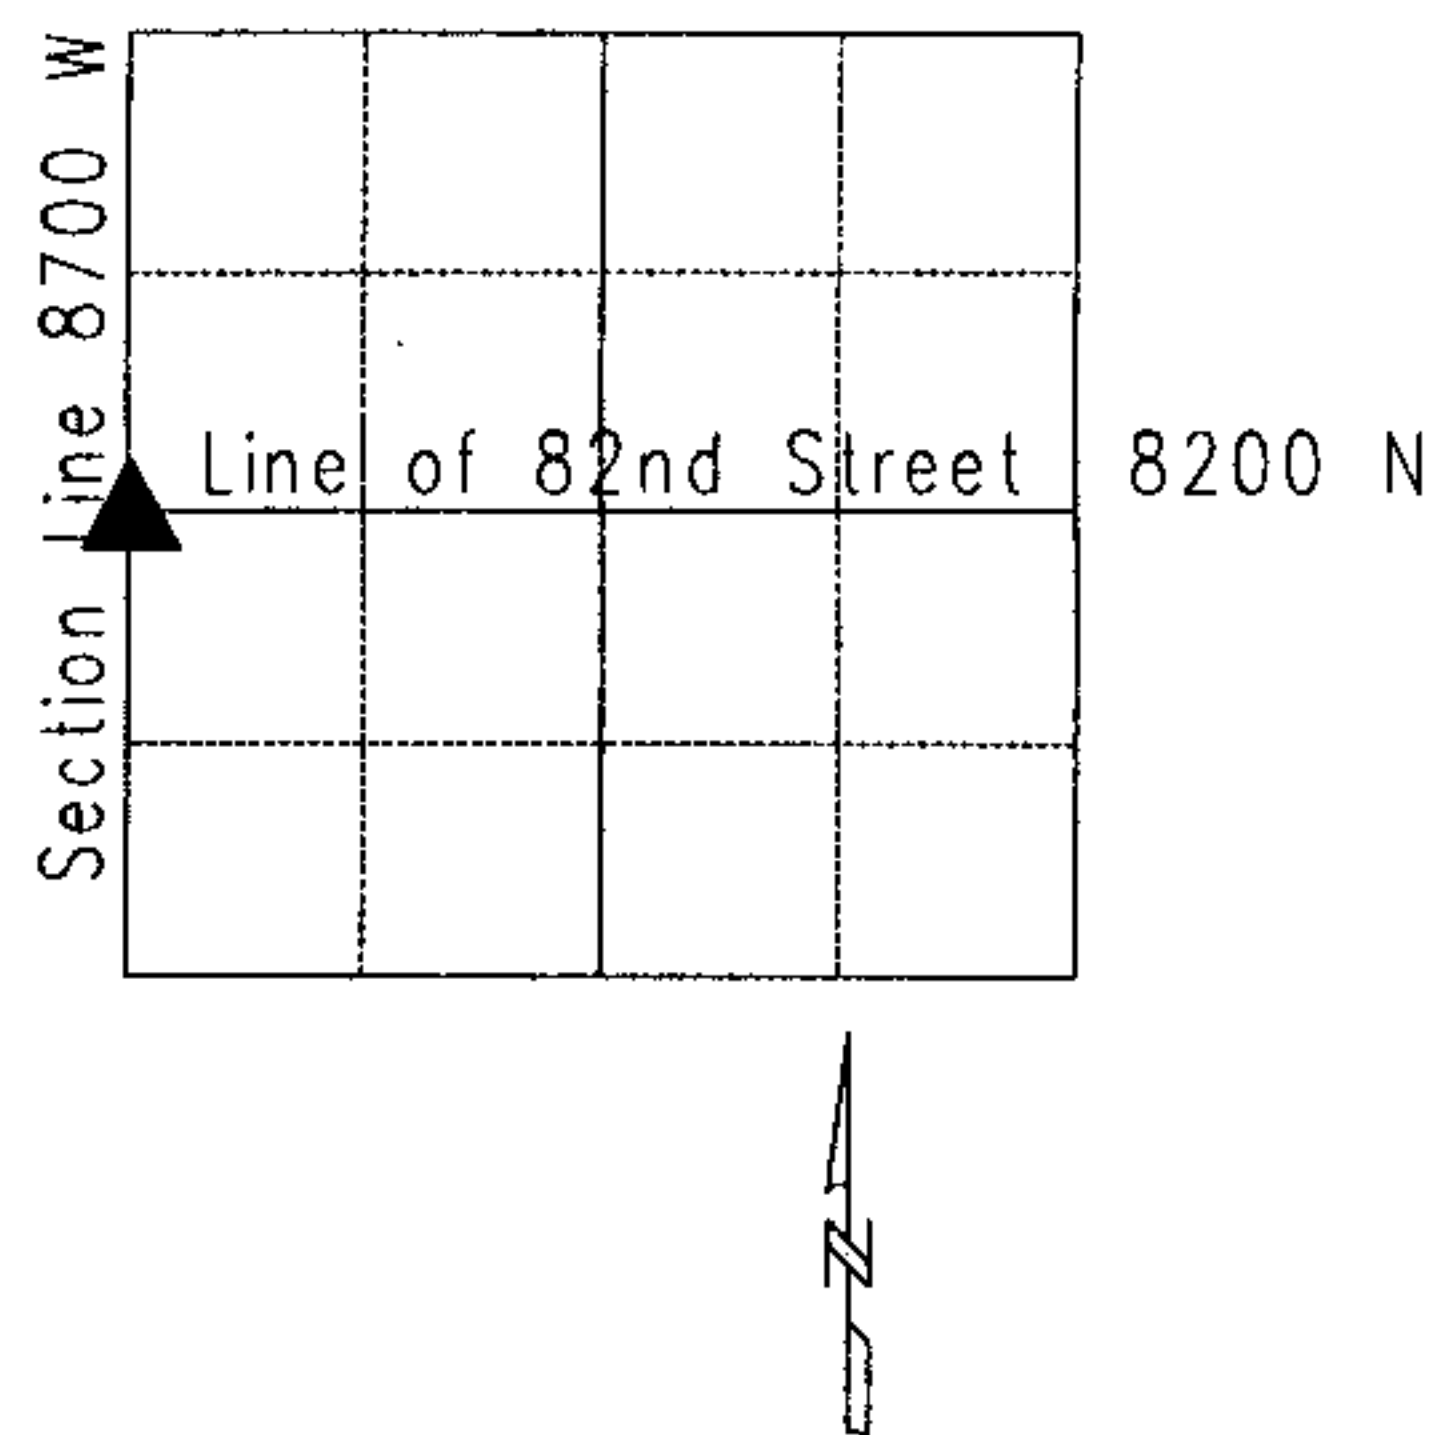
TYPE OF MARKER: Brass plug set-in fd

METHOD OF ESTABLISHMENT: County: bridge-deck  
EDM ties

IN. S.P.C. E ZONE, NAD 83

NAME: 17022104

N: 516889.2192(m)

E: 44426.0560(m)

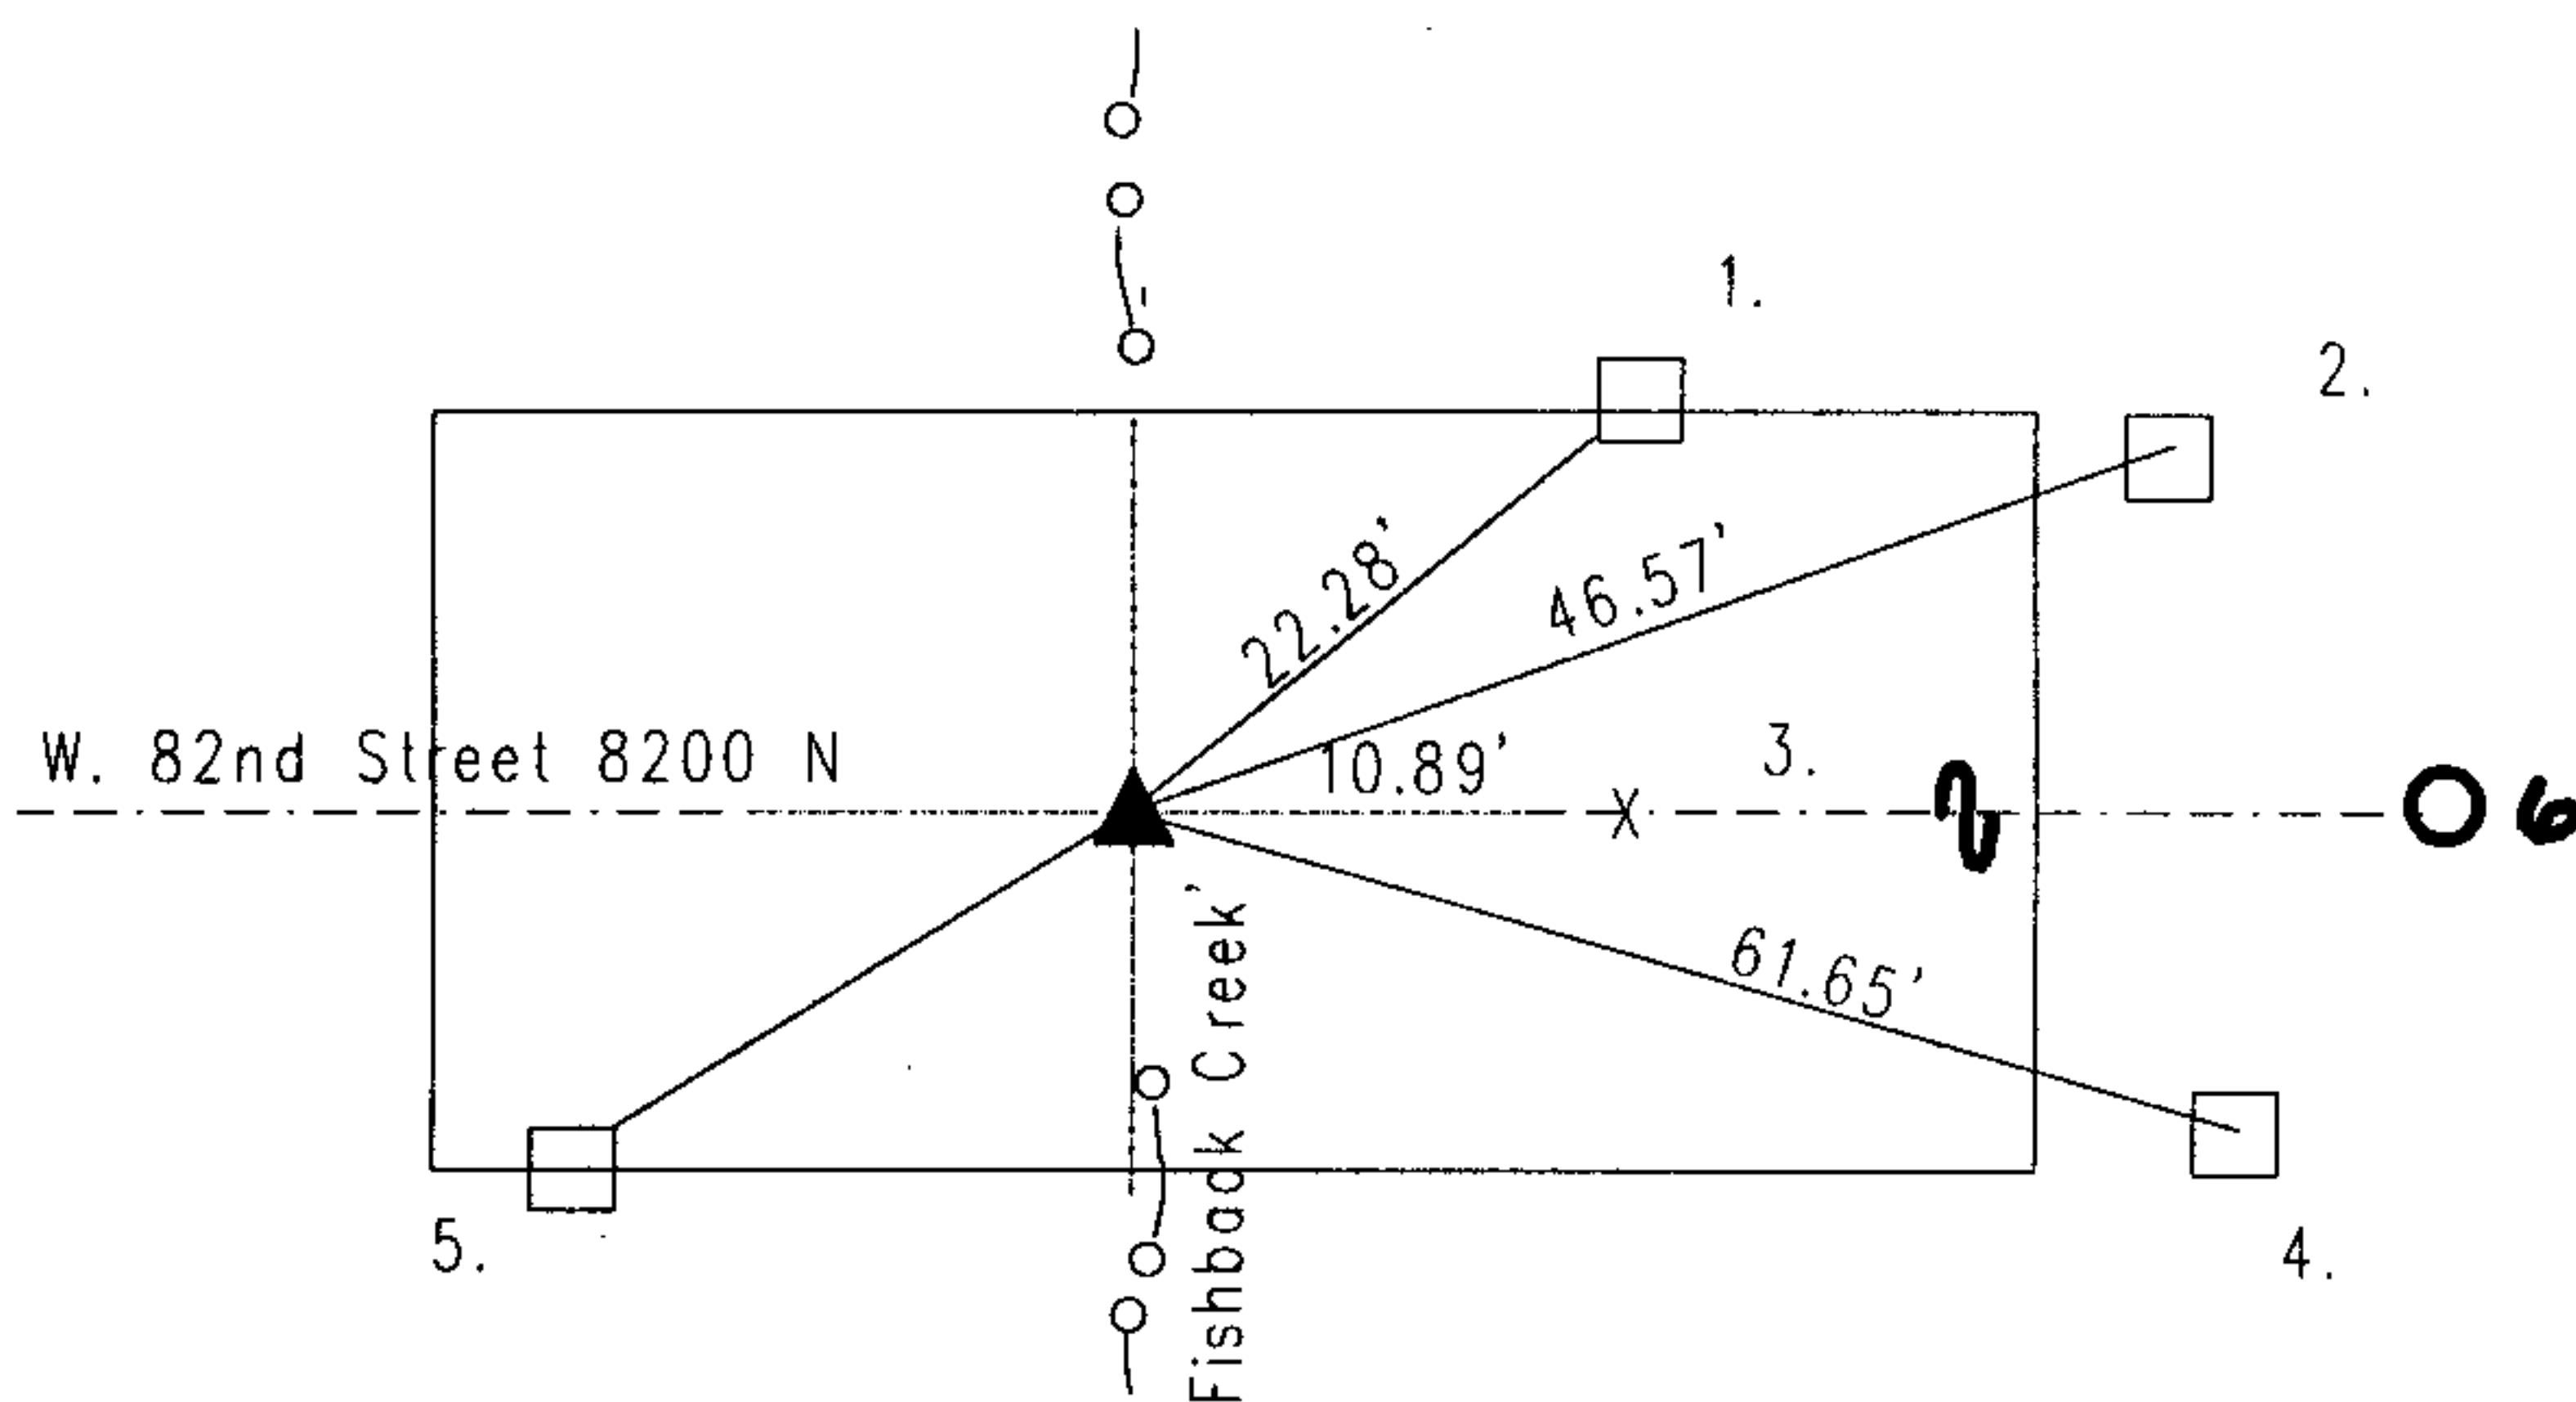
17022104

REF.	DISTANCE	DESCRIPTION
1.	22.28'	Cut 'x' SW-bolt of drain inlet
2.	46.57'	PK nail w/washer top wooden guard post
3.	10.89'	Cut 'x' on bridge deck
4.	61.65'	PK nail w/washer top wooden guard post
5.	19.69'	Cut 'x' NE bolt of drain inlet
6.	147.73'	C/L Harrison monument found
